Clun Unmuddying the Waters Project Activity Report - April 2020 to March 2021

Prepared by Alison Jones, Clun Catchment Officer

March 2021

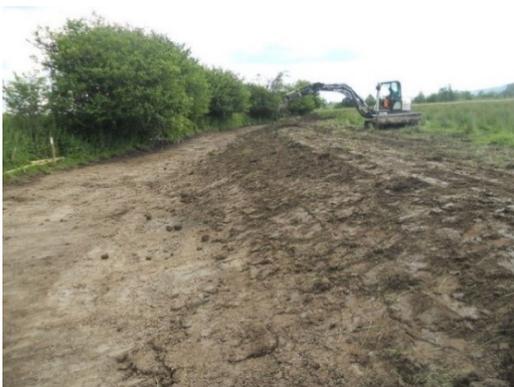
Swale & bund creation in progress. July 2020.

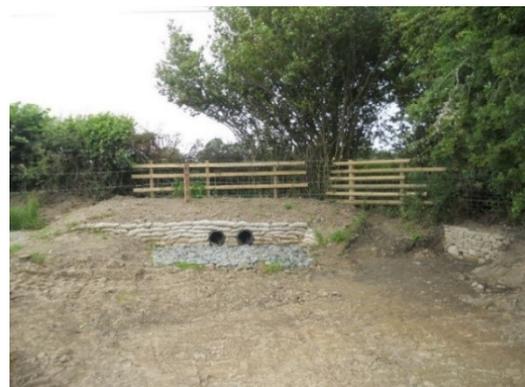
New outfall with headwall completed & backfilled. July 2020.

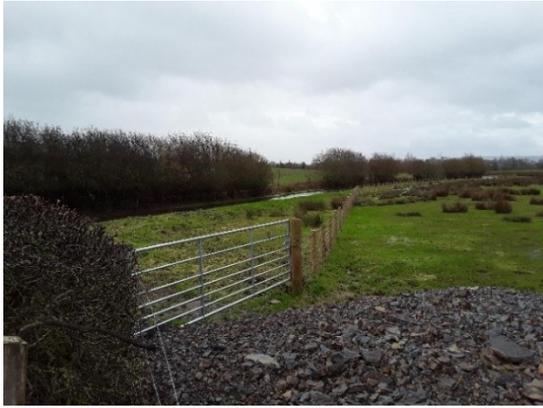
Swale fenced and gated with track access to headwall for maintenance & repair. July 2020.

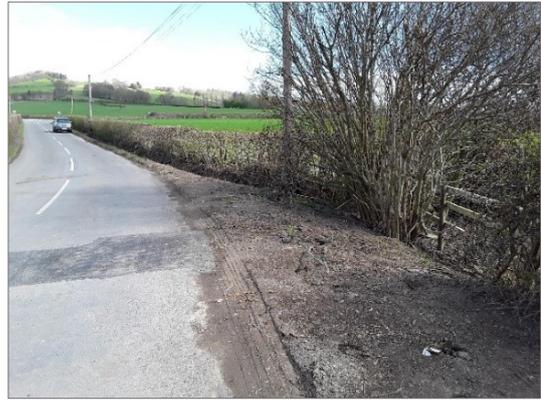
Roadside ditch carrying road runoff to new swale. July 2020.

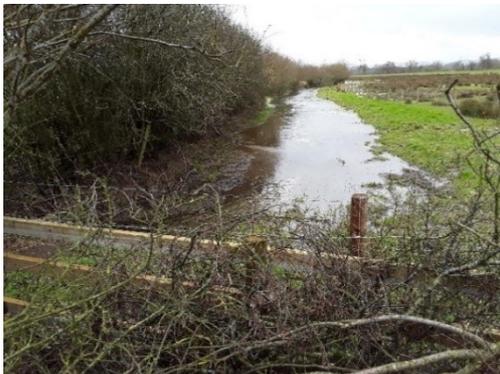
Functioning swale close to capacity. February 2021.

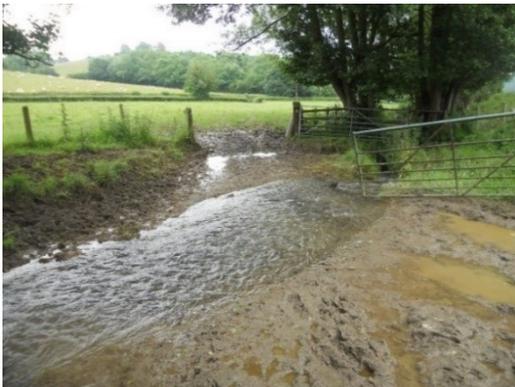
Regular use of this ford by vehicles, combined with stock access, has led to poaching and erosion of the banks, and siltation and faecal contamination of the watercourse. This is contributing to sediment laden runoff to the brook, and ultimately into the River Clun.

BEFORE. Crossing from right bank.

1. Installation of 1200mm pipe culvert, with headwalls and stone covered track over.
2. Associated fencing rails, netting and wire fencing and gates.
3. Replacement of stile with a pedestrian gate on Public Right of Way. The gate and posts were supplied by Shropshire Council.

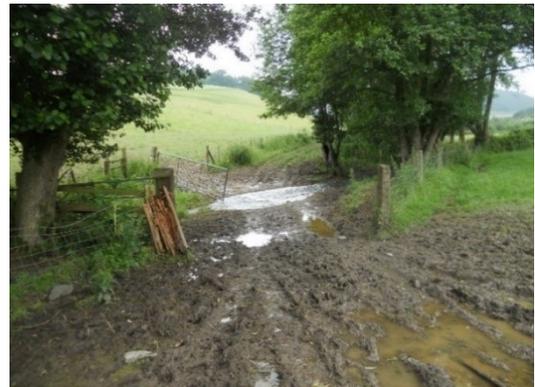
BEFORE. Crossing from left bank.

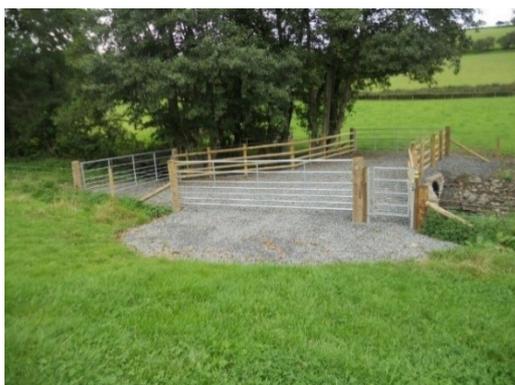
AFTER. View from right bank. Culvert installed, fenced & gated, plus pedestrian gate on PRow.

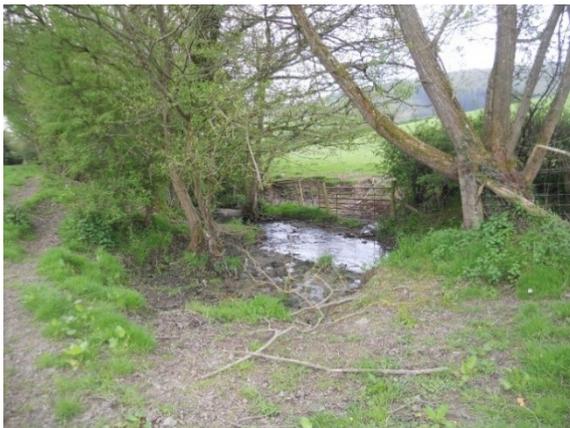
BEFORE. Stock crossing and watering point.

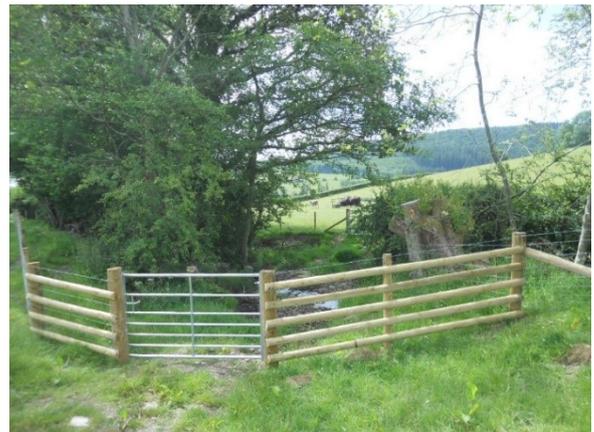
AFTER. Crossing closed. Gate for emergency access only.

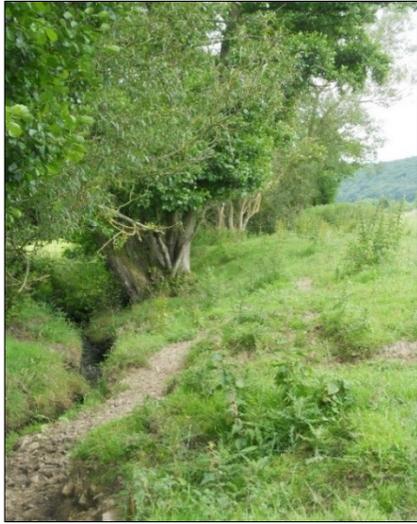
Unlimited stock access to the stretch of [REDACTED] Brook between the new bridge and the new culvert has resulted in poaching and bank erosion and limited opportunities for natural regeneration of tree or shrub cover.

BEFORE. Stock access to brook resulting in poaching and bank erosion.

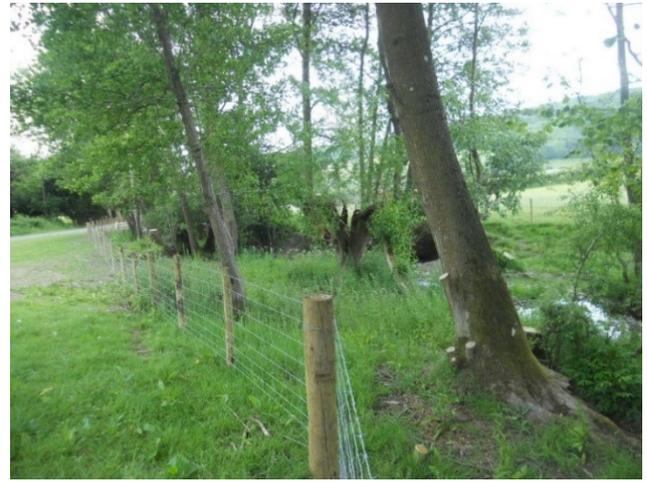
AFTER. Fenced buffer strip to protect existing trees and encourage natural regeneration.

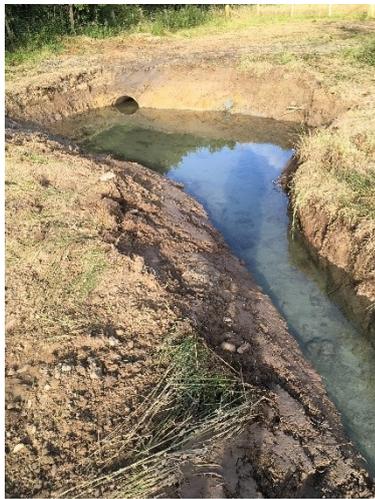
New outfall after pipe removal. Large pool created to minimise impact during high flow.

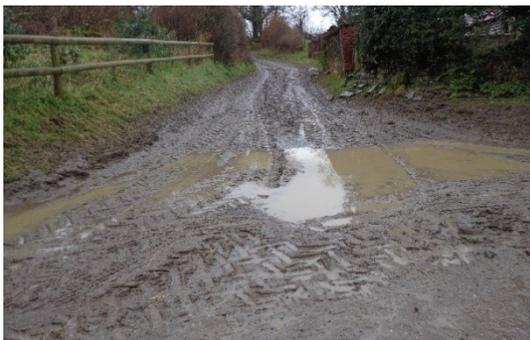
Sediment laden runoff was being transported from a well-used farm track onto the unclassified road, from where it flowed downhill and into a minor tributary of the Kemp.

Farm track showing sediment laden runoff being carried onto road.

1. Installation of a cross drain to intercept runoff.
2. Install catchpit with sump linked to pipe to carry runoff to outfall into ditch.
3. Re-excavate and regrade ditch to carry runoff away to existing pool.

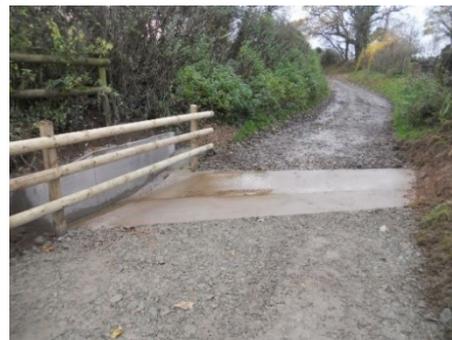
Concrete dish cross drain built in situ to intercept track runoff.

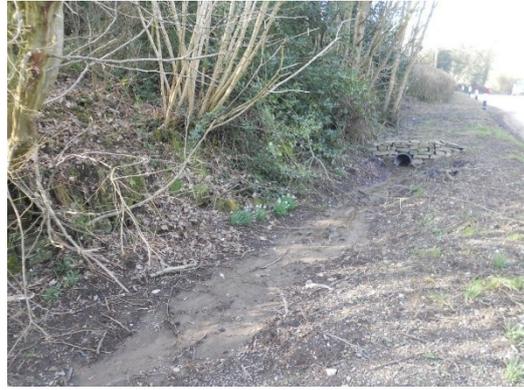
Pipe installed and outfall protected with stone headwall.

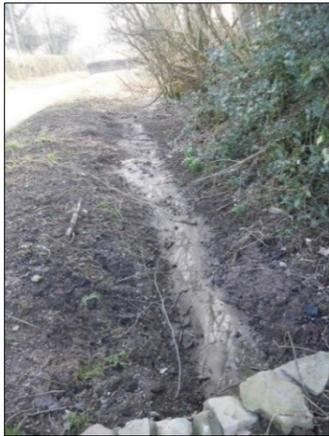
Open ditch from outfall showing silt settling out from the runoff.

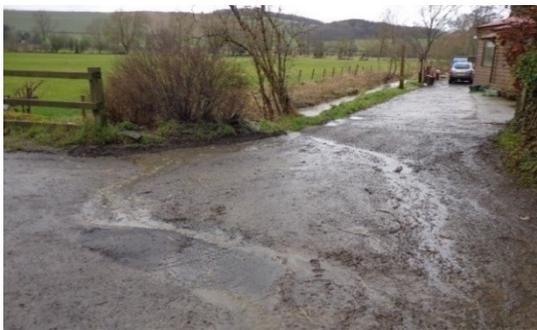
Runoff, flowing downhill from [redacted], entering watercourse by [redacted] Lodge.

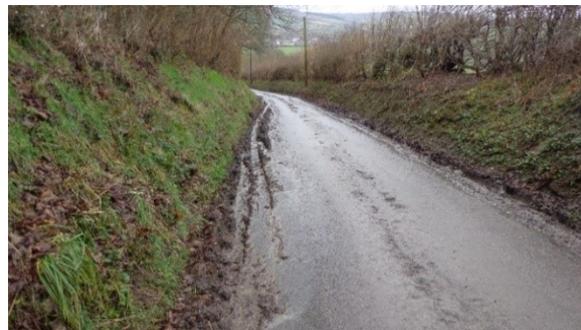
Overrun of road verges between [redacted] and [redacted].

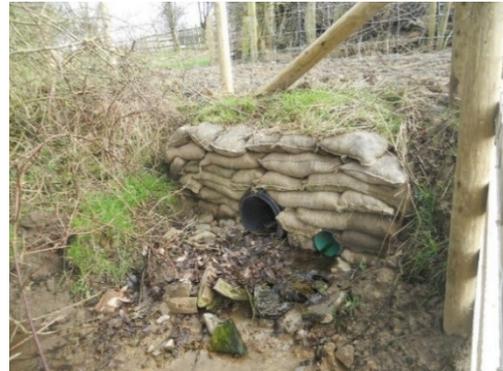
Outfall into field ditch, protected by bagged headwall and new fences.

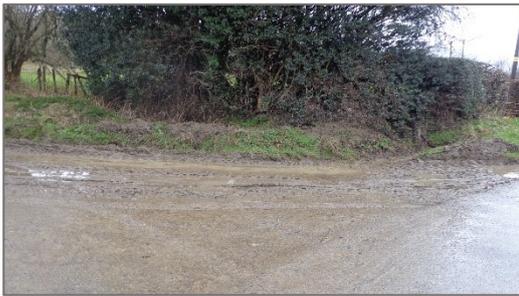
Runoff flowing onto highway and ditch

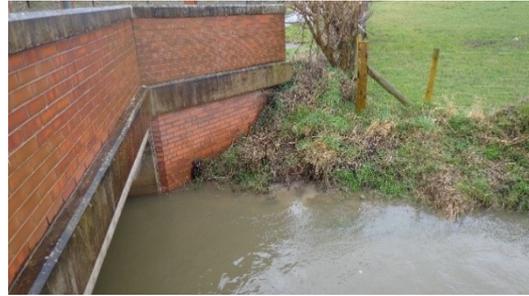
The outfall was identified as a "red flag" site, in the "*Survey of the Highway Drainage Network in the River Kemp Sub-Catchment*", completed by Mike Kelly in March 2016. It was considered to be causing a disproportionate adverse impact. See photographs below, from survey report.

Pipe outfall to river, showing silt plume

1. Replacement of broken sections of pipe carrying runoff from catchpit to outfall into river.
2. Repairs and upgrade to headwall of outfall.

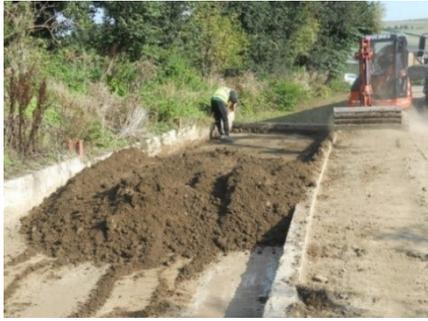
Site preparation: clearing the catchpit, swale & trackside of accumulated sediment

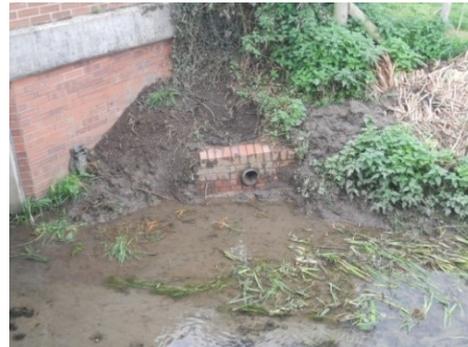
Outfall to river with new brick headwall

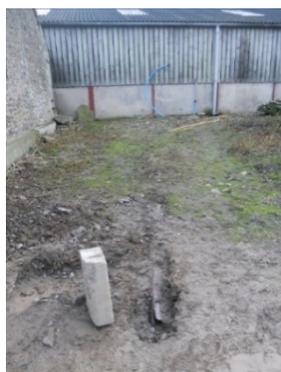
Damaged pipe exposed

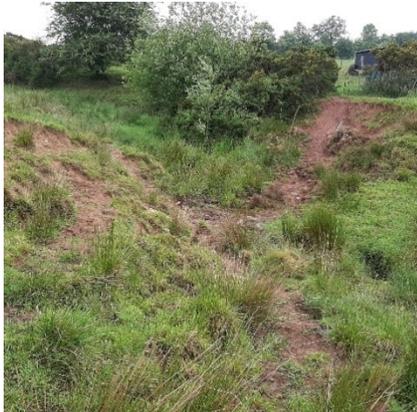
BEFORE. Stock access to watercourse leading to soil erosion.

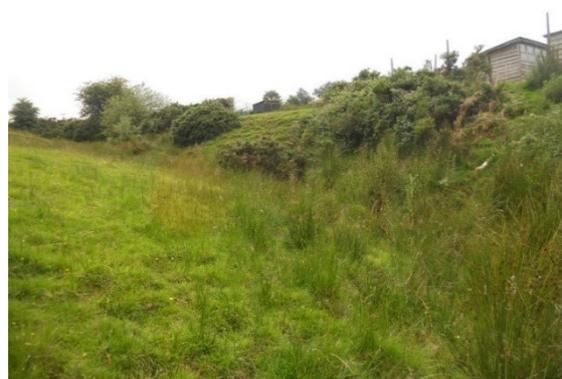
BEFORE. Unfenced habitat of wet flushes and gorse scrub.

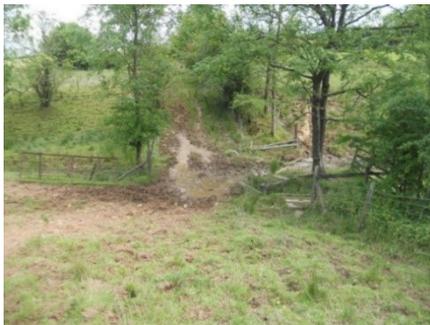
Crossing point. Heavily used by livestock and vehicles. Existing culvert is damaged.

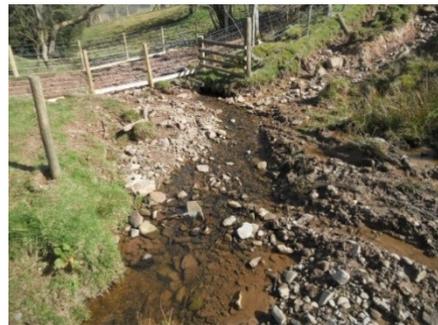
Stock & vehicle crossing point now closed off, limiting gully erosion on bank.

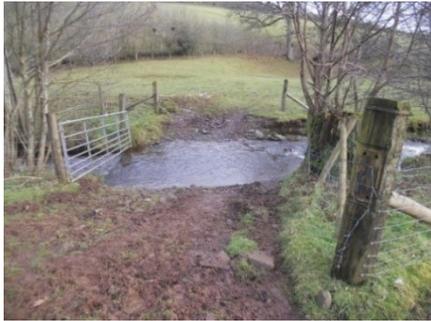
BEFORE. Crossing on Folly Brook, in regular use by stock and farm vehicles.

1. Upgrade to crossing over the Folly Brook, including the installation of bespoke river gates.
2. Fencing section of [REDACTED] to exclude stock from watercourse and dingle woodland.

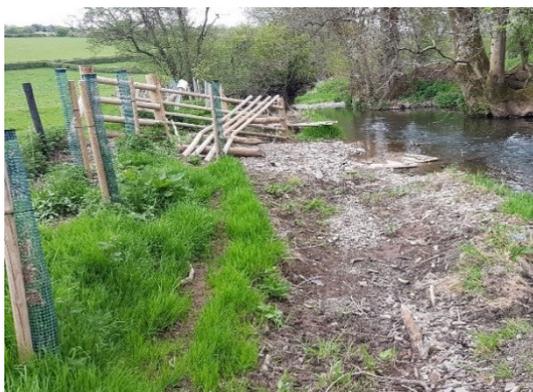
On two landholdings, drinking bays were the landowners preferred option, rather than the provision of solar powered livestock drinking systems. The heavy and prolonged floods during the winter of 2019 to 2020 resulted in damage to the drinking bays and adjacent fencing.

Drinking bay damaged by flood debris.

- Repairs were completed to the drinking bay using existing materials, which had not been washed away.

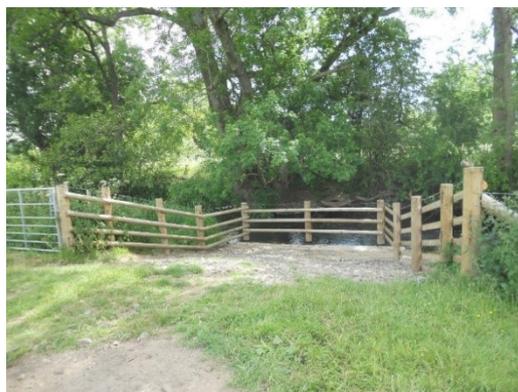
Drinking bay repaired and fences reinstated, also protecting young trees.

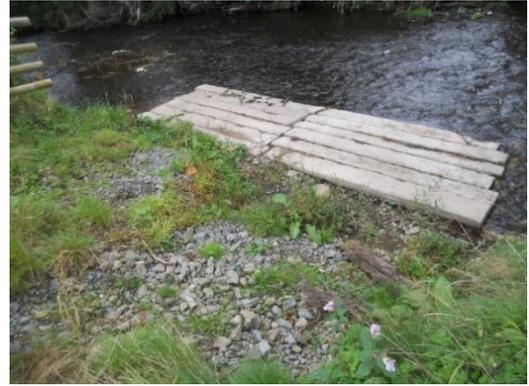
AFTER. The flood damaged drinking bay. September 2020.

1. The installation of a solar pump kit plus galvanised water trough.
2. Installation of a gate to the drinking bay, for use in emergency situations only.

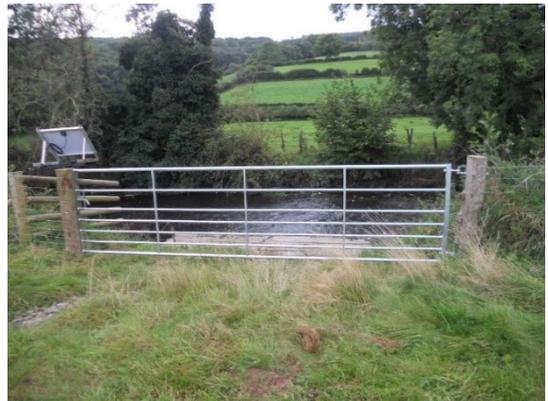
Drinking bay gated. Will only be used to access the river in an emergency.
