Summary

Brook Vessons Headwater Restoration Project

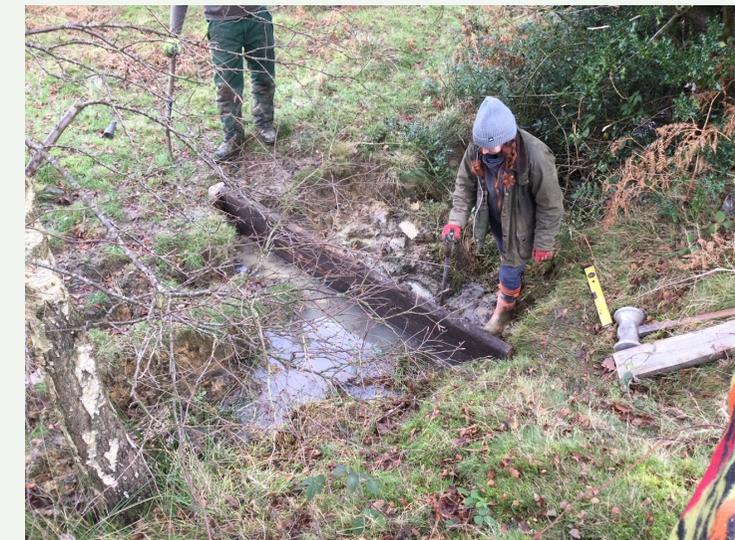
With consents in place, local contractors were engaged and the ditch was blocked with a series of bunds using locally sourced timber, soil and coir matting. The water outfall from the ditch was immediately reduced as lateral flows of water from the ditch onto adjacent land were established. The bunds revegetated rapidly.

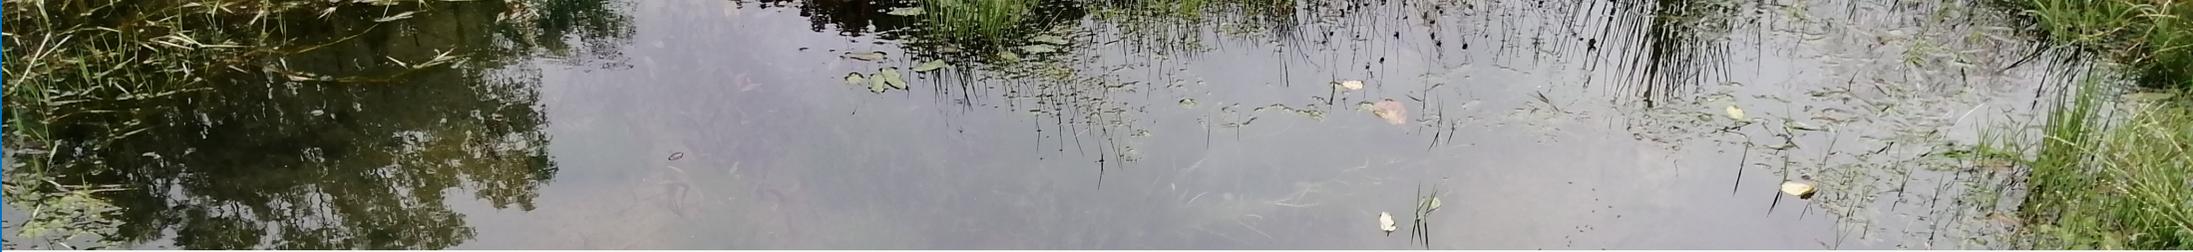
Downslope of the ditch/bank there was an extensive network of land drains. We had accurate maps of all drains, which amounted to several km, so total removal was not possible within the project budget and possibly not desirable due to the amount of soil disturbance that would be required. Due to abrupt vegetation changes visible it was possible to locate land drains on the ground and break them at strategic points to disrupt the flows.

The outflows from the drains are now much reduced or down to zero and the areas of formerly improved grassland are rapidly re-wetting. Over time we expect the vegetation types to adapt to the wetter conditions and reflect more closely the semi-natural vegetation community on the reserve.

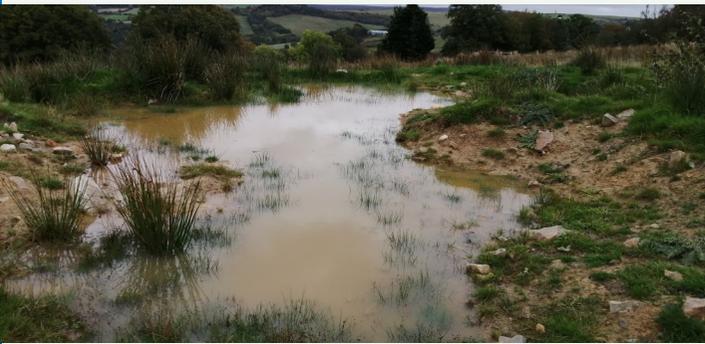
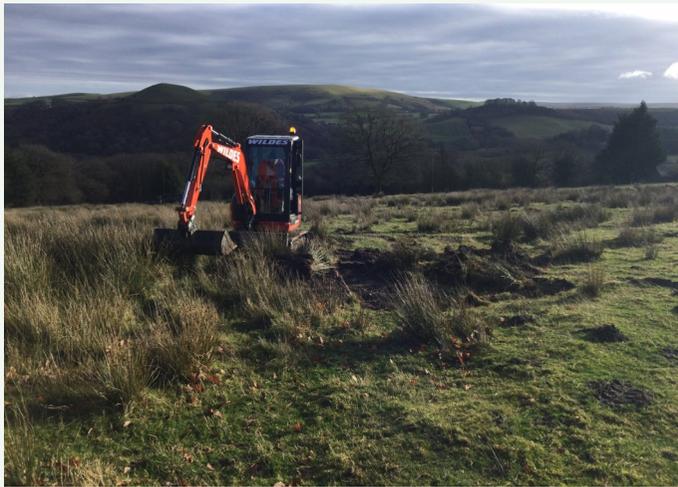
The project created several small wildlife ponds and scrapes, adding to the other open water habitats nearby. Pond creation had a double purpose, allowing the project to source close to hand the soil and turf materials necessary to create the in-ditch plugs.
