Clun Unmuddying the Waters Project Activity Report - April 2019 to March 2020

Prepared by Alison Jones, Clun Catchment Officer

April 2020

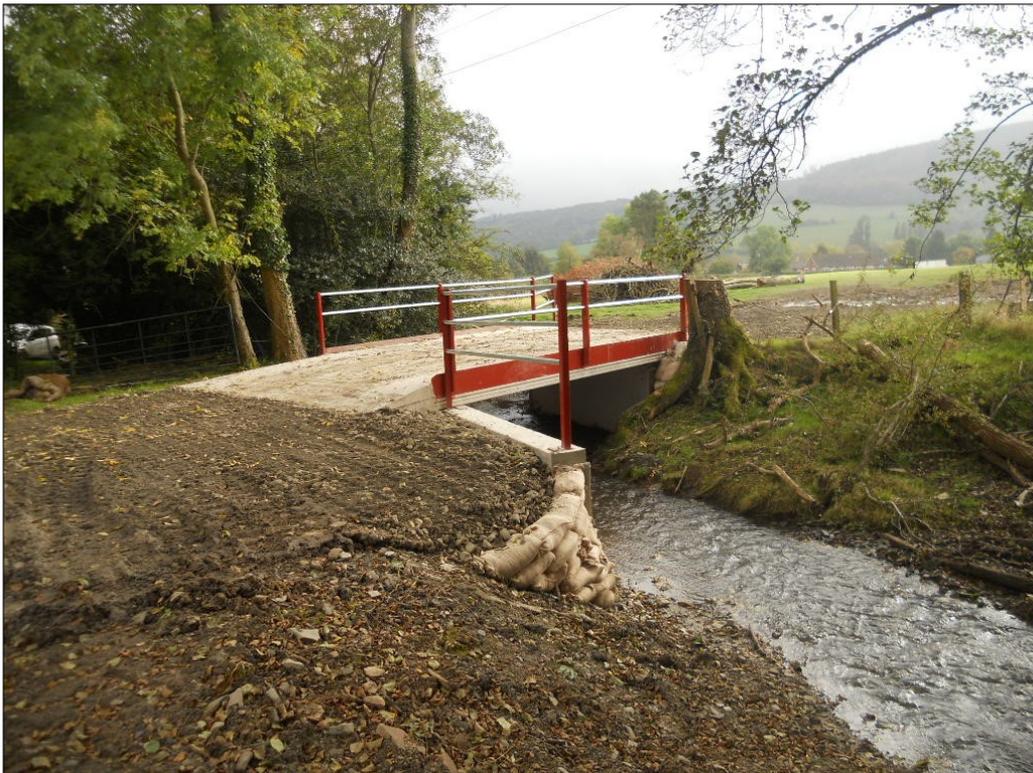
Bridge installed over Clunton Brook to replace livestock and vehicle crossing.

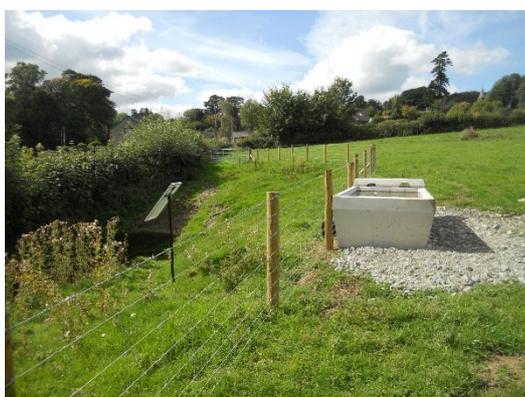
Trough plus old 30W panel at installation.

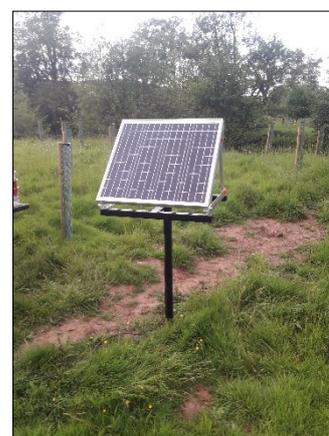
60w panel mounted on homemade frame

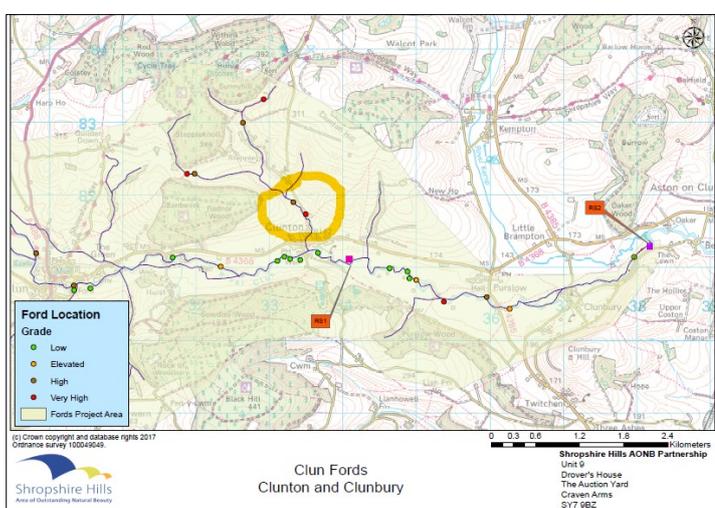
Map: Fords at Clunton & Clunbury.

Site circled in yellow:

Site 1 (red) is the location for a new bridge.

Site 2 (brown) is due to be culverted.

Heavy use by vehicles at site 1, combined with uncontrolled stock access to the crossing has resulted in poaching and erosion of the banks, and siltation and faecal contamination of the watercourse itself. This is contributing sediment laden runoff to the brook, which flows into the Clun at Clunton, and ultimately into the River Clun SAC and Teme SSSI.

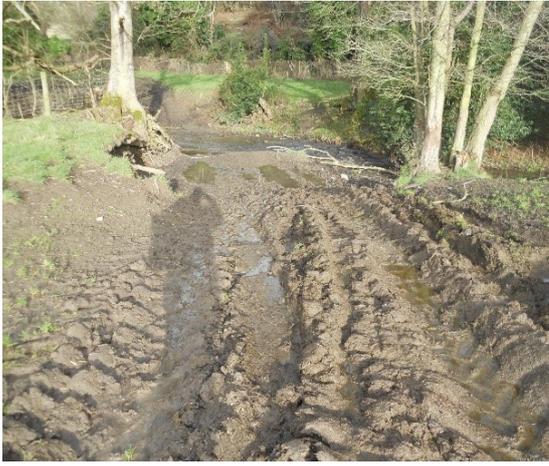
BEFORE: Crossing from right bank

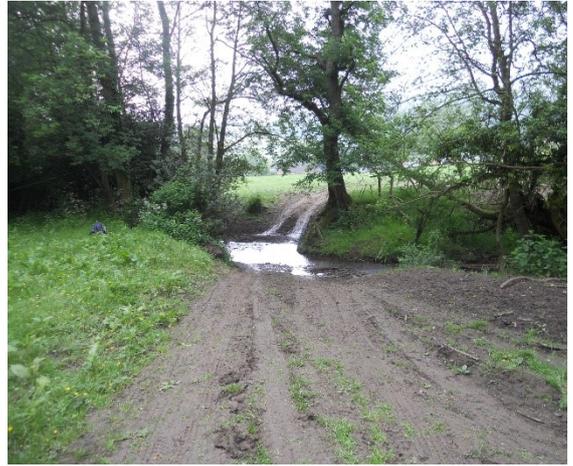
BEFORE: Crossing from left bank

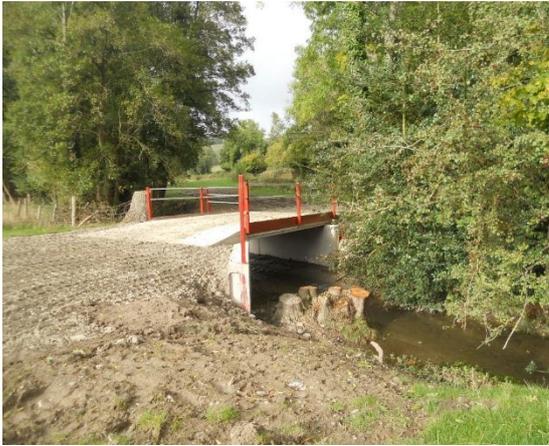
AFTER: New bridge from right bank

The site was unsuitable for a culvert, so the decision was made to construct a bridge to replace the degraded crossing point. The bridge was designed with the capability of carrying a maximum load up to 20 tonnes and was constructed in September 2019.

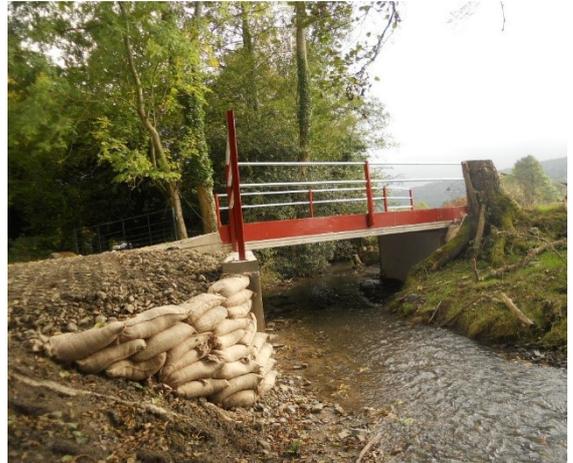
AFTER: New bridge viewed from left bank

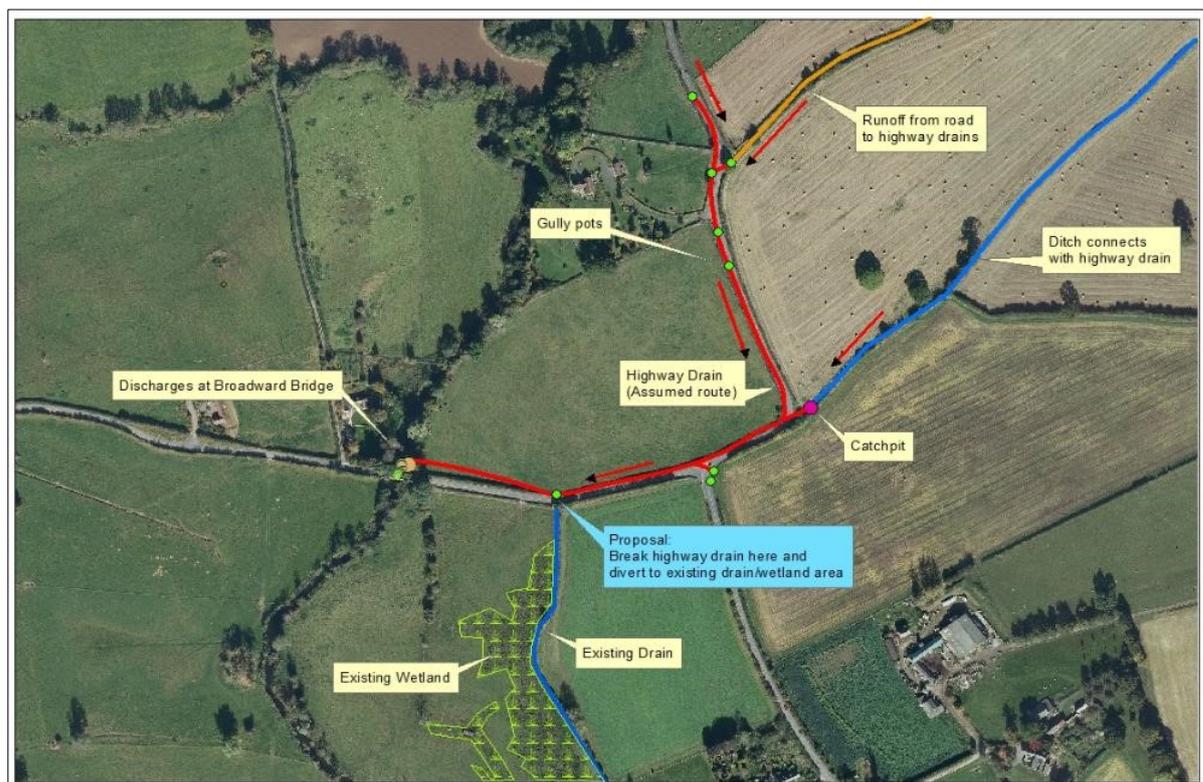
The map below is extracted from this document and shows how this area is a collection point for runoff. Multiple highway gully pots and ditches intercept sediment laden runoff and vehicle overrun, all of which is routed into a highway drain outfall at Broadward Bridge, at the head of the Clun SAC.

An agreement was reached between all parties concerned to intercept the highway drain and reroute it under the road, to discharge into the wetland area. An existing drain or ditch (marked on OS maps) provides a conduit to the wetland area, and plans included reprofiling this to create a wide shallow swale. The area is already subject to flooding, but the expectation is that existing and regenerating vegetation will capture any sediment conveyed to site.

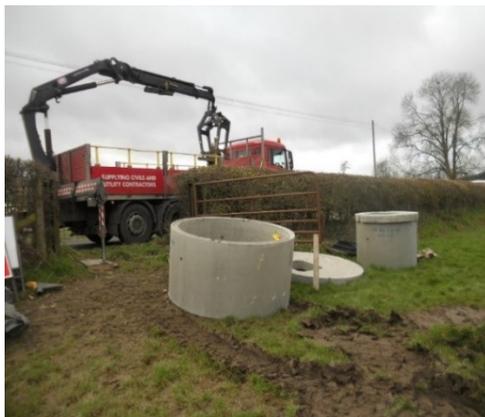
Delivery of concrete catchpits

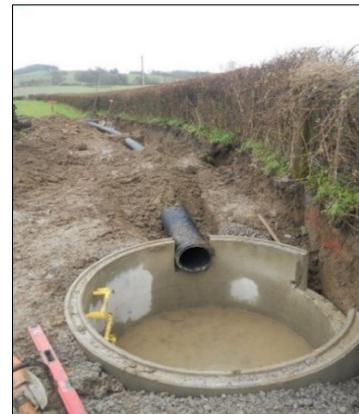
Catchpit with new supply pipe installed

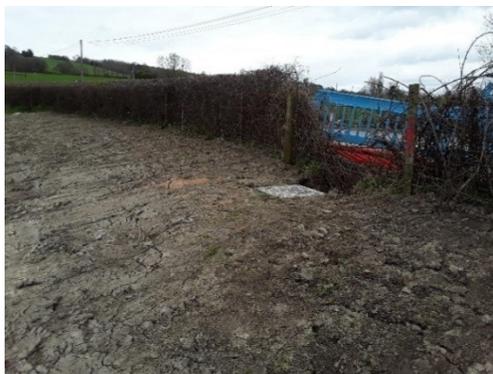
Catchpit with manhole cover and new pipe backfilled and covered with soil.

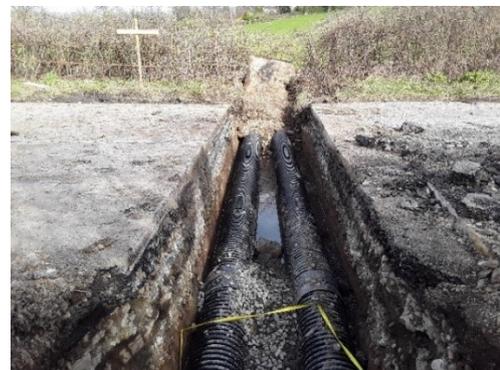
Culverted road crossing showing two 300mm twin wall pipes

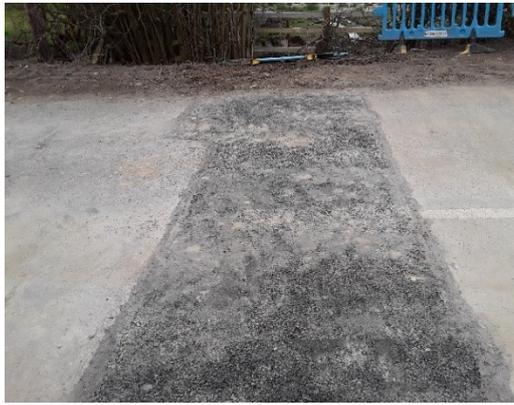
Road crossing completed, with tarmac covering

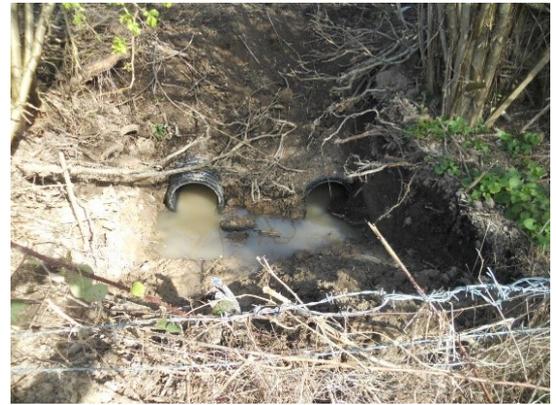
New culvert, showing temporary outfall

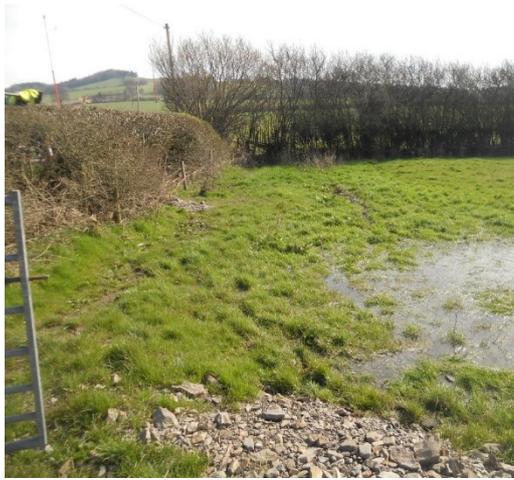
Location for new access track to headwall & outfall

Due to the difficult ground conditions, a new track was constructed from the field gate to enable the contractors access to the field corner, to construct the outfall and headwall.

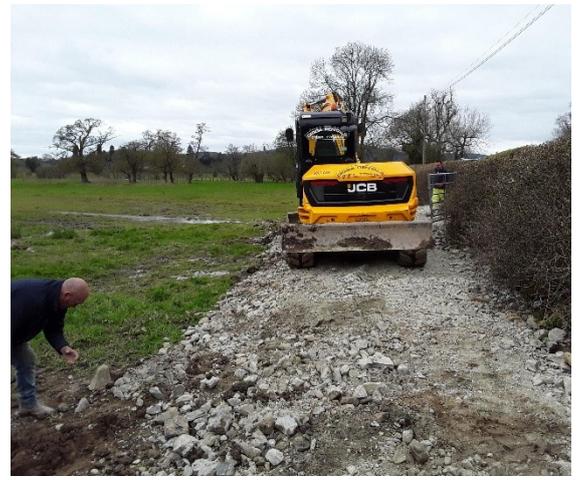
Track laying in progress

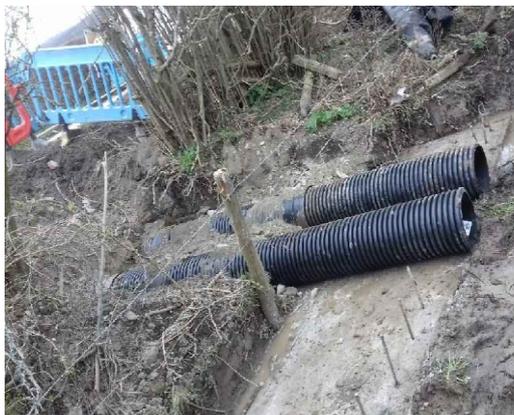
Base for headwall complete and culvert pipes extended

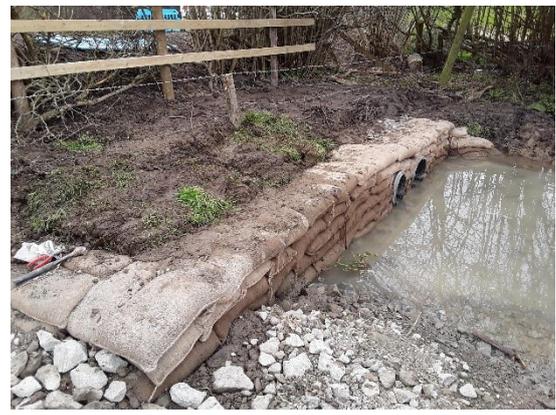
New outfall with headwall completed

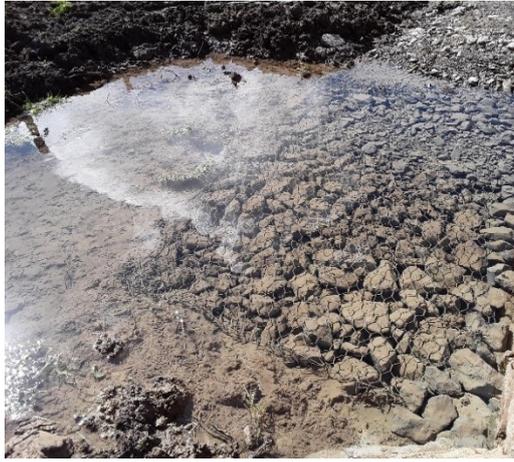
Headwall with gabion mattress apron for erosion control

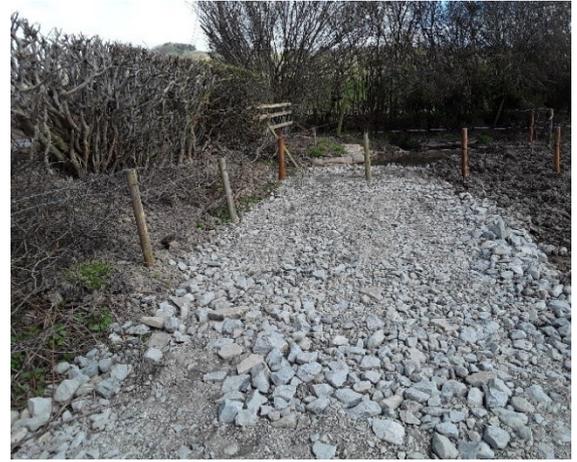
Temporary fence to protect new outfall and headwall

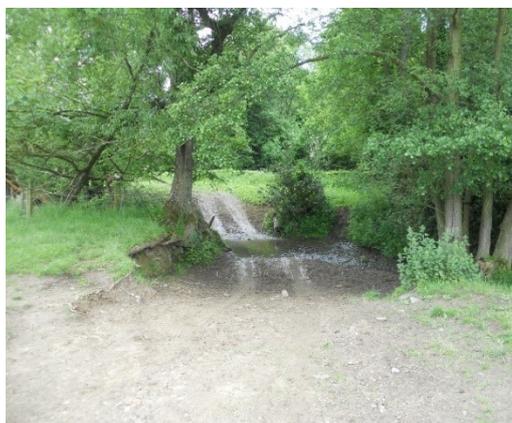
BEFORE: Approach to crossing; semi mature Ash on left & Alder on right.

When plans for the new bridge had been agreed, some tree surgery was deemed necessary prior to construction. A semi mature Ash tree to the left of bridge, already showing signs of disease, was considered to be a risk as it might destabilise the bridge foundations. To the right of the bridge, a mature Alder was coppiced, as the overhanging branches would be damaged by vehicles using the bridge. The regrowth can be managed to prevent this in future.

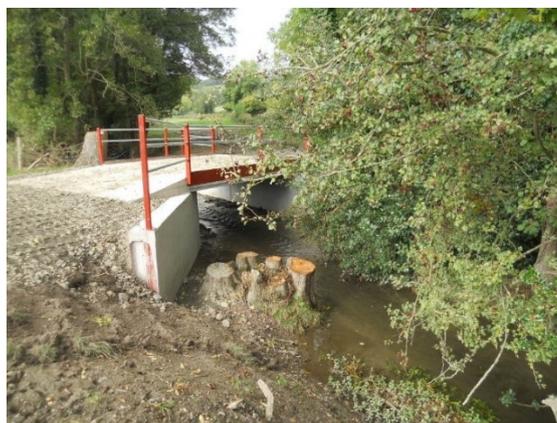
AFTER: New bridge with Ash stump to left and coppiced Alder to the right.

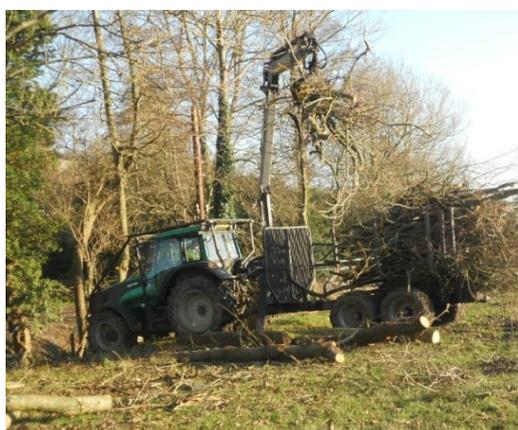
Tree coppicing in progress

In preparation for fencing of the watercourse, selective coppicing of Alder, Ash & Hazel and Willow pollarding was carried out, focussing on vulnerable, unstable and diseased trees.

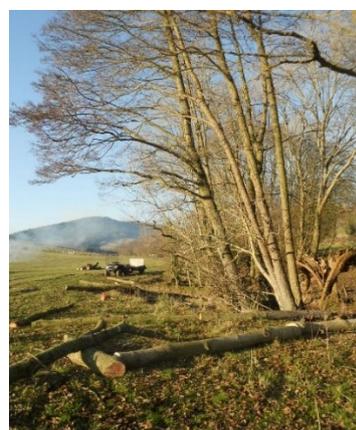
Selective coppicing of Alder and Ash

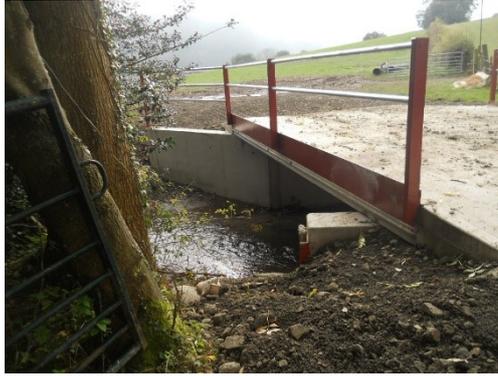
BEFORE: Railings with large gap

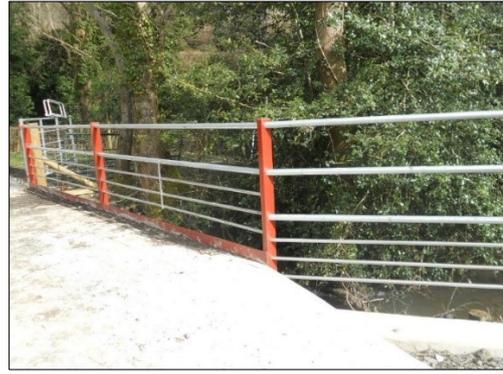
AFTER: Additional rails installed to make stockproof for sheep & lambs

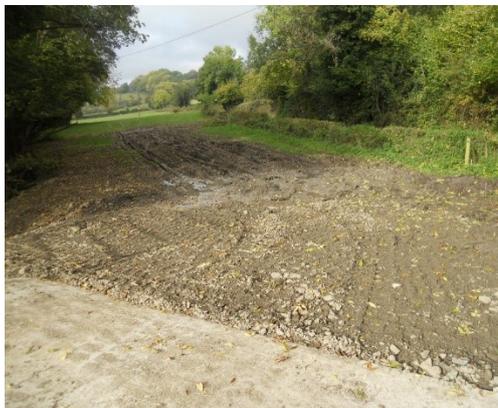
BEFORE: Rutting and compaction created during bridge installation

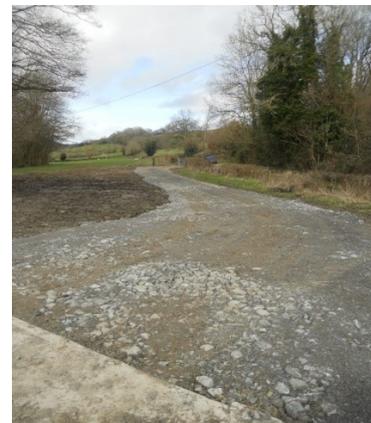
AFTER: Roadside gate realigned, to meet regraded track with new stone surface.

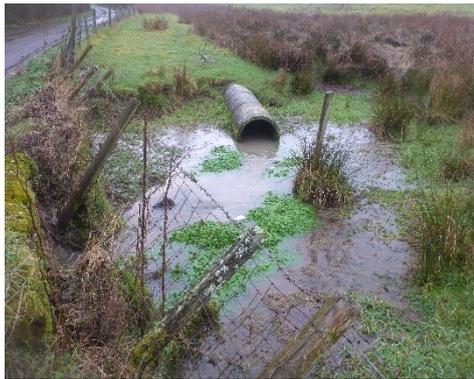
The outfall has been identified as a "red flag" site, in the "*Survey of the River Redlake Sub-Catchment Highway Drainage Network*", carried out by Mike Kelly in March 2017. It was considered to be causing a disproportionate adverse impact. See photographs below, extracted from the survey report.

Outfall into pool. Shows colouration from sediment laden run-off

Recommendations in the Survey Report were to remove a section of pipe and so allow the outflow to discharge over a larger area, and for this wetland to be stock fenced to reduce the impact of poaching by livestock.

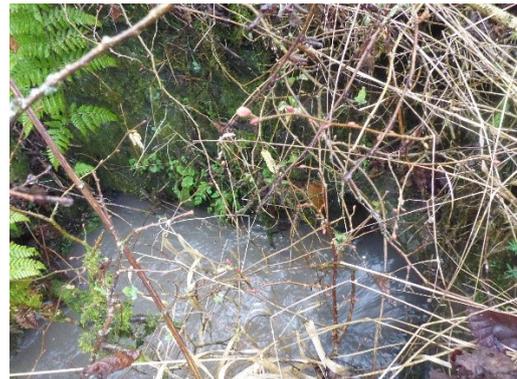
Outfall of road culvert. Shows sediment plume

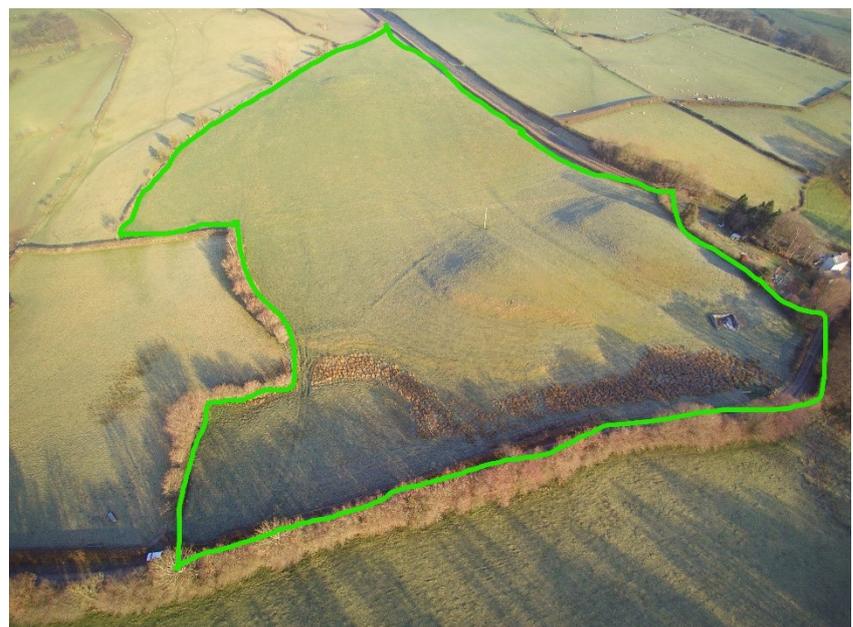
Aerial view of holding, with boundary in green.

A copse and shelterbelt has been planted next to north west boundary.

The wetland is to the south of the holding.

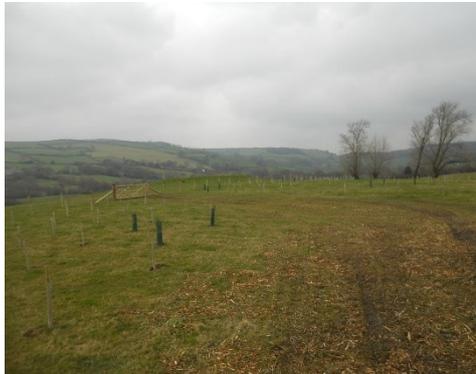
Track through new copse to new fence & gate

Two lengths of internal fencing were erected; one protects the newly planted copse and shelterbelt from grazing livestock. The second protects the wetland area from poaching damage and will enable the creation of wet woodland, planned for the autumn.

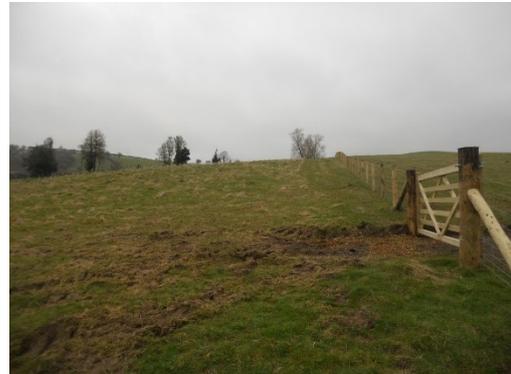
Newly fenced woodland with gated access

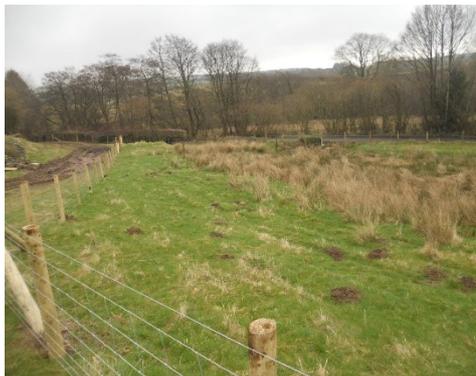
New fencing to protect wetland from livestock poaching

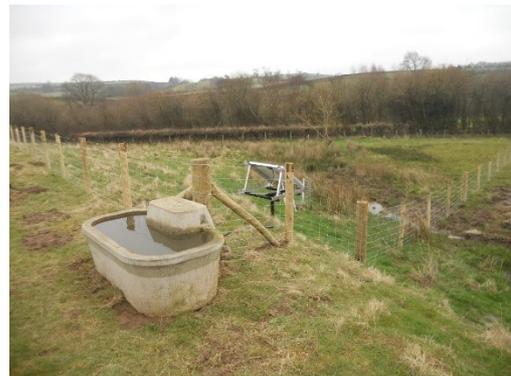
Livestock drinking trough supplied by solar powered pump

A solar powered pump system supplies drinking water for stock from a reused trough.

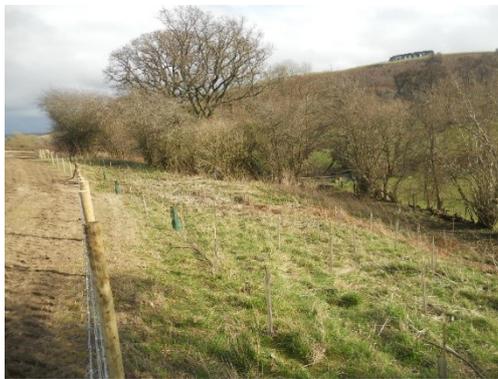
New fence to protect scrub and new tree planting

Two lengths of internal fencing were erected; one to protect young trees planted a year ago, to create a buffer strip adjacent to a ditch. The second protects a newly planted riparian woodland next to the River Kemp, adding to the significant area of new riparian woodland already established along this stretch of the river.

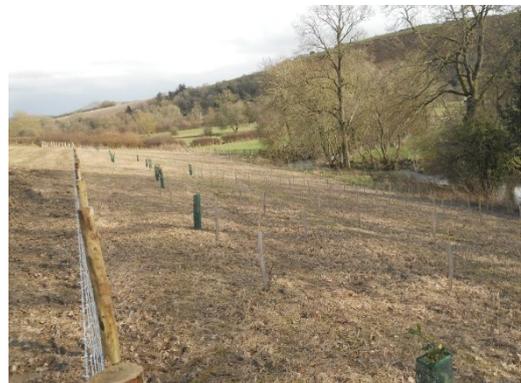
New fence to protect new riparian woodland
