Clun Unmuddying the Waters Project Activity Report - April 2020 to March 2021

Prepared by Alison Jones, Clun Catchment Officer

March 2021

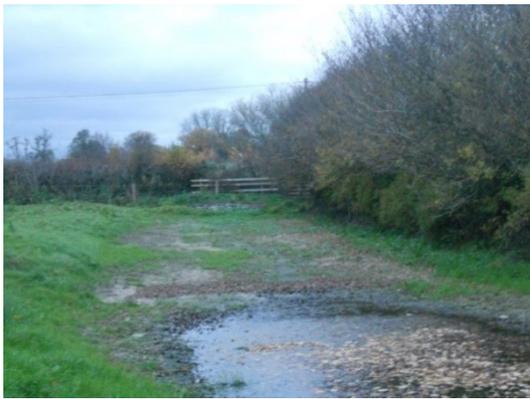
Top of swale. November 2020.

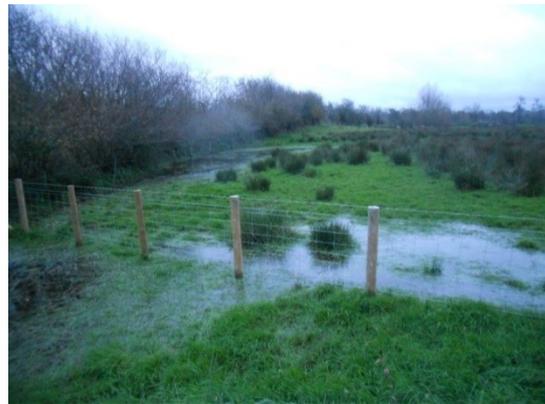
Water drawn to end of swale and disperses across lowest areas of meadow. November 2020.

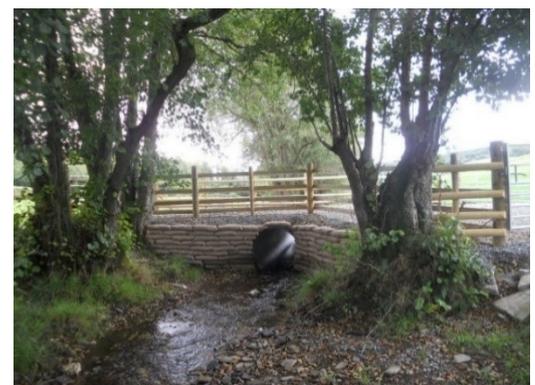
AFTER. Upstream view of new culvert.

1. Installation of 1200mm pipe culvert, with headwalls and stone covered track over.
2. Associated fencing rails, netting and wire fencing and gates.
3. Replacement of stile with a pedestrian gate on Public Right of Way. The gate and posts were supplied by Shropshire Council.

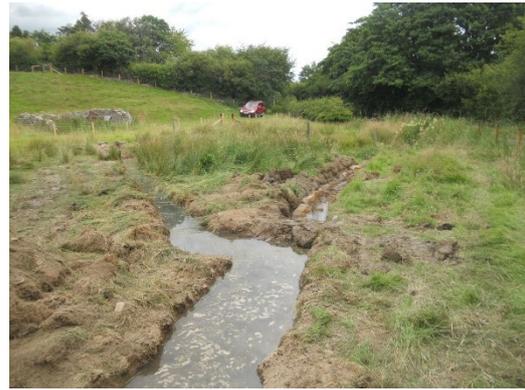
Existing channel plugged. Flow diverted to side channel and new pool. Silt mats placed in old channel to trap disturbed sediment.

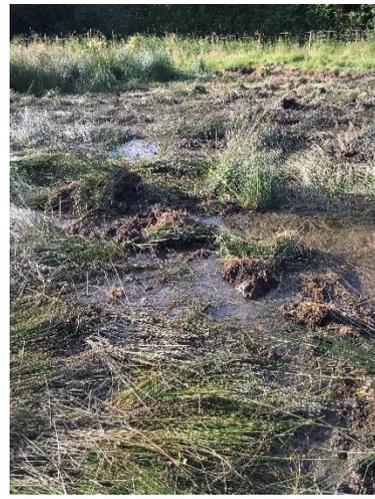
Ground completely saturated at downstream end of site, by day 4.

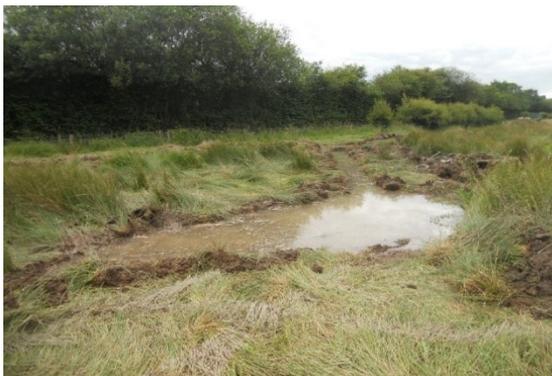
Downstream (east) end of wetland. Side channel and pool creation. July 2020.

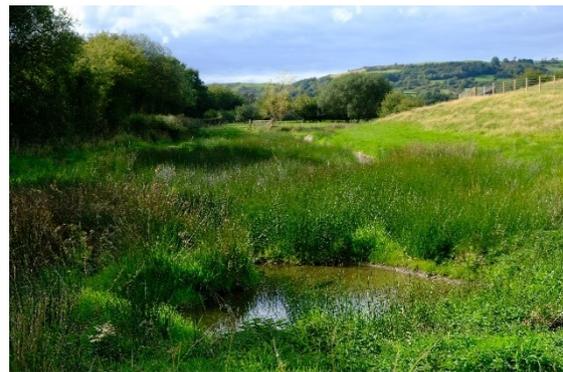
Side channel and pool. Shows extent of recovery & recolonization. September 2020.

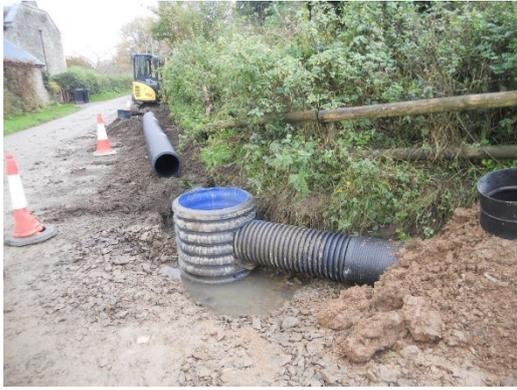
Catchpit with sump showing pipe to be installed along roadside verge.

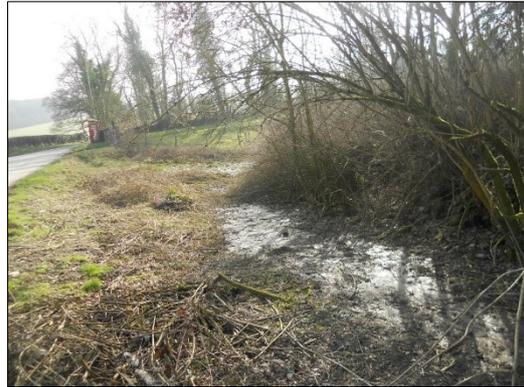
Runoff flowing gradually towards pool, allowing sediment to settle out.

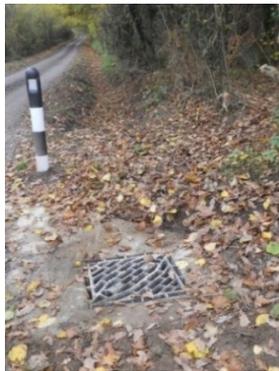
Grid covered catchpit & sump, receiving runoff from restored roadside ditch.

- Reinstatement of both roadside ditches, to effectively transport road runoff to catchpits.

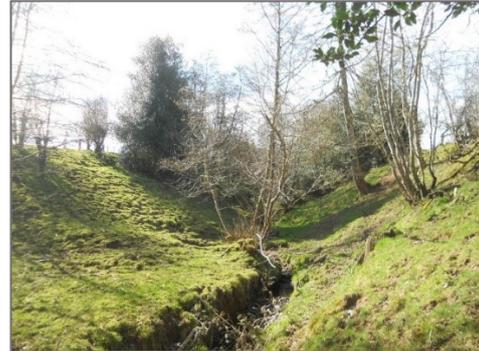
Open dingle woodland. Fenced to encourage regeneration and improve bank stability.

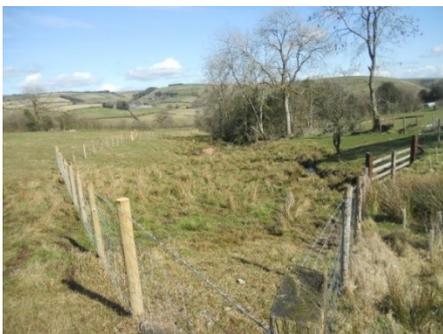
Wetland. Fenced to limit stock access. Soil runoff reduced and plant diversity increased.

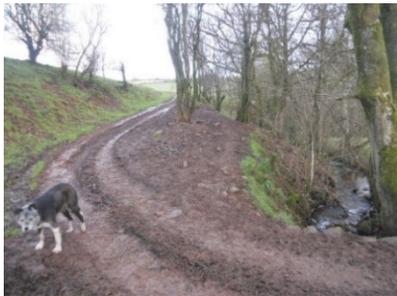
BEFORE. Track & bank vulnerable to erosion.

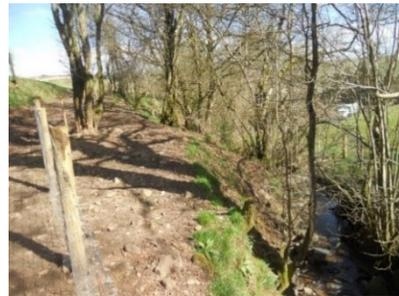
AFTER. Fenced track and woodland

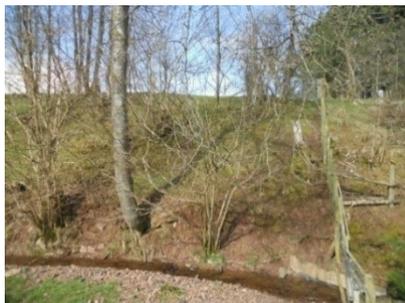
AFTER. Steep bank fenced, to improve stability through regenerating tree and shrub cover.

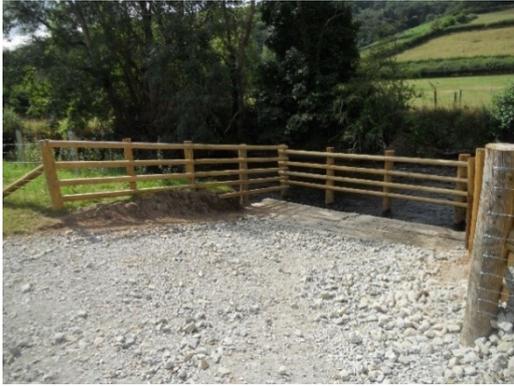
On two landholdings, drinking bays were the landowners preferred option, rather than the provision of solar powered livestock drinking systems. The heavy and prolonged floods during the winter of 2019 to 2020 resulted in damage to the drinking bays and adjacent fencing.

BEFORE. The newly completed drinking bay. July 2018.

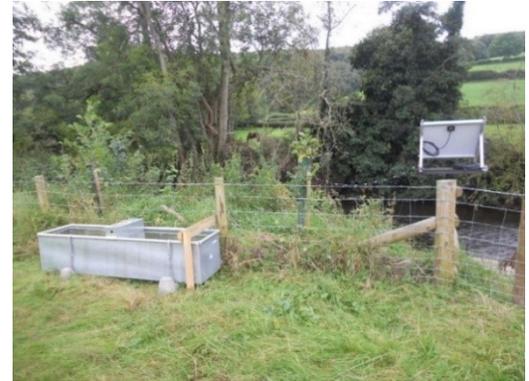
Trough secured to ground with service box to protect float switch.

After discussion with the landowner regarding the likelihood of further flood damage, and the need for repeated repairs, he accepted the offer of a solar pump system to provide a sustainable source of water for his livestock.
